**50 Years Later – The
Legacy of the 1964
Flood in the Redwood
Creek Watershed**

Mary Ann Madej, USGS-WERC

Long-Term Legacy of the 1964 Flood

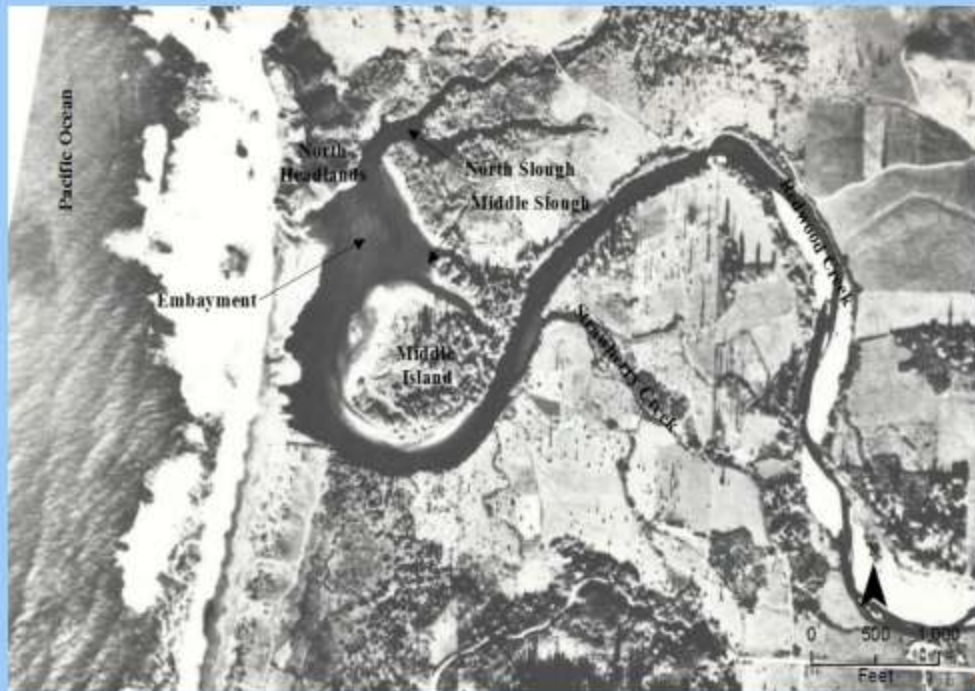
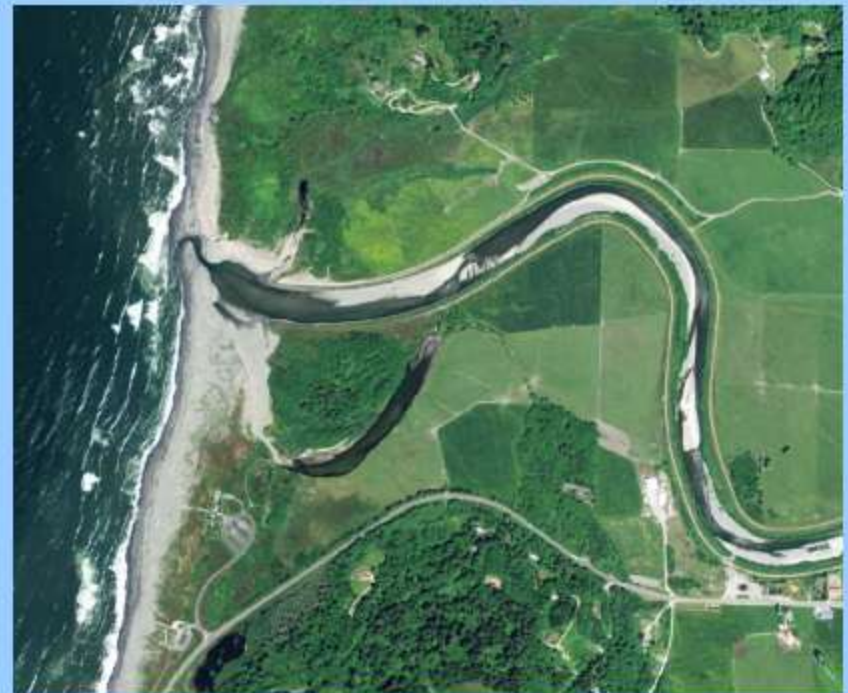
Construction of flood control levees in 1968 dramatically changed circulation patterns in estuary

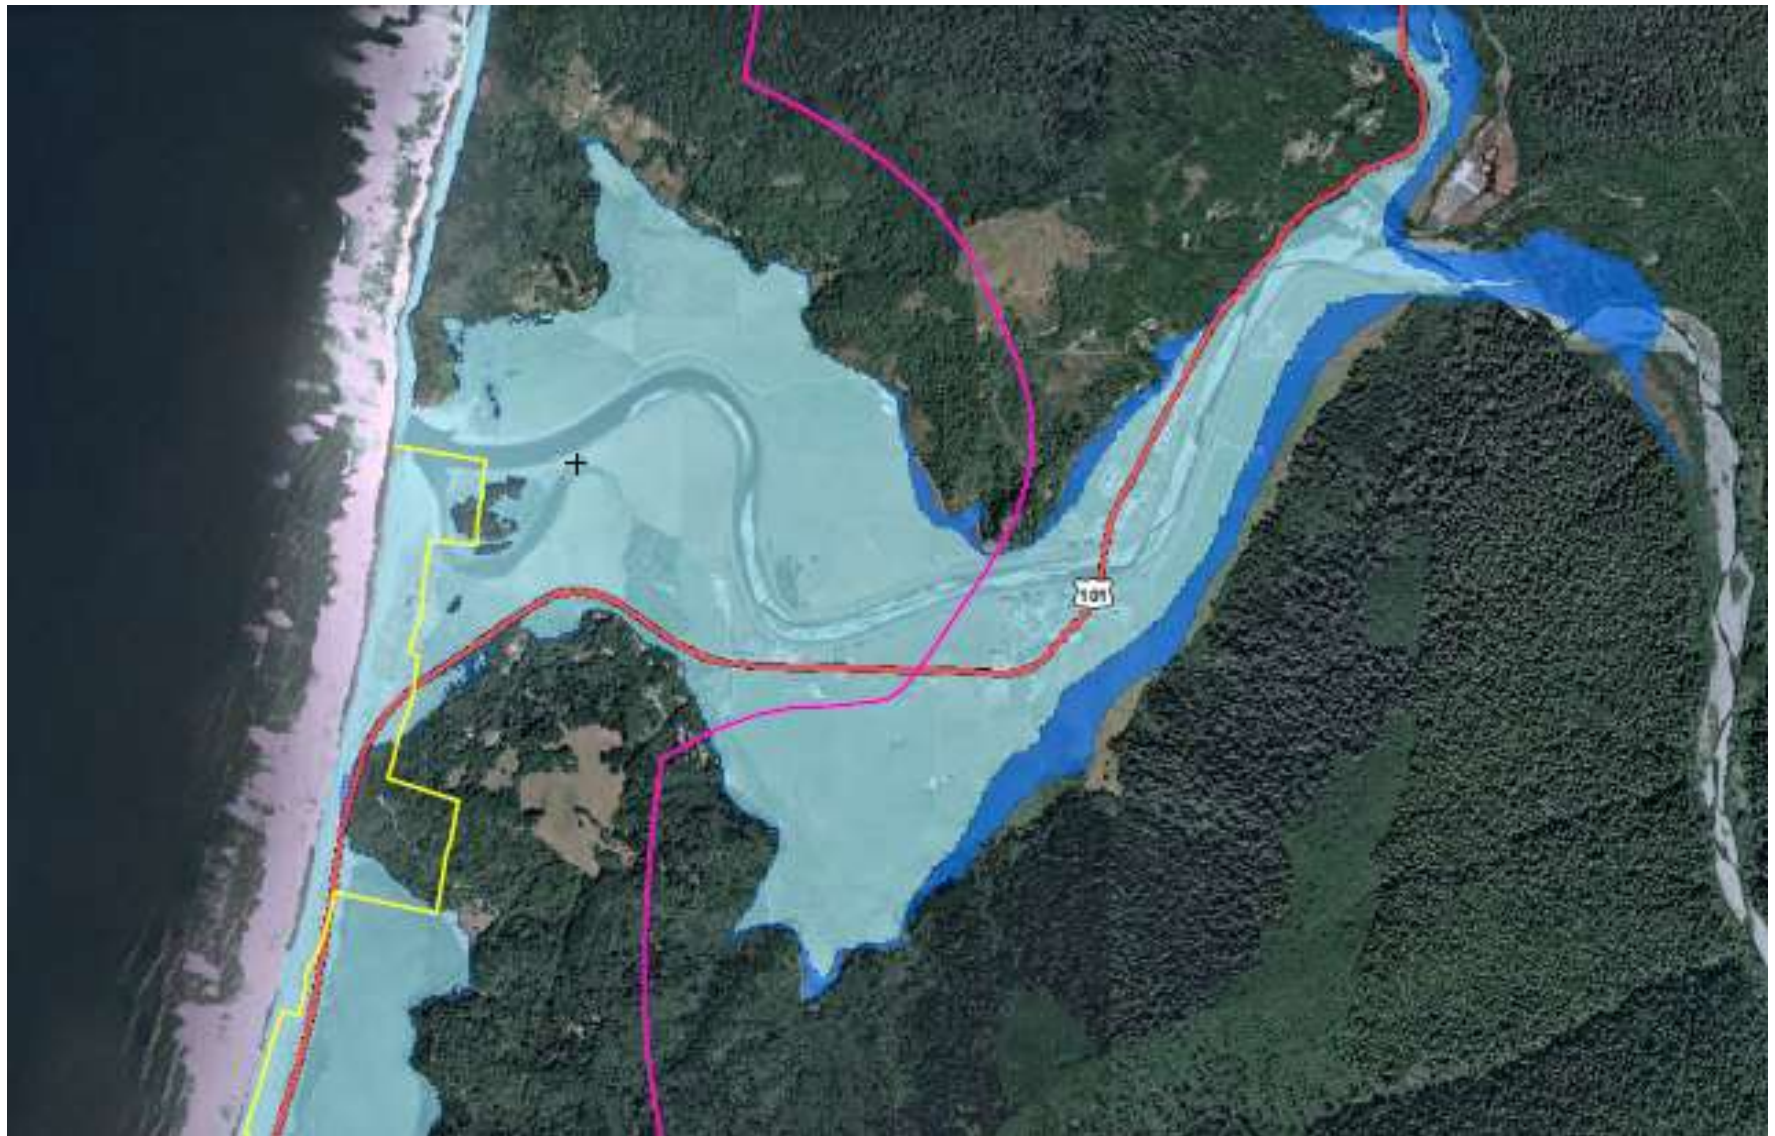
100-year flood inundation map for Orick valley
(Data from USGS, NOAA, USDA, NASA and more)

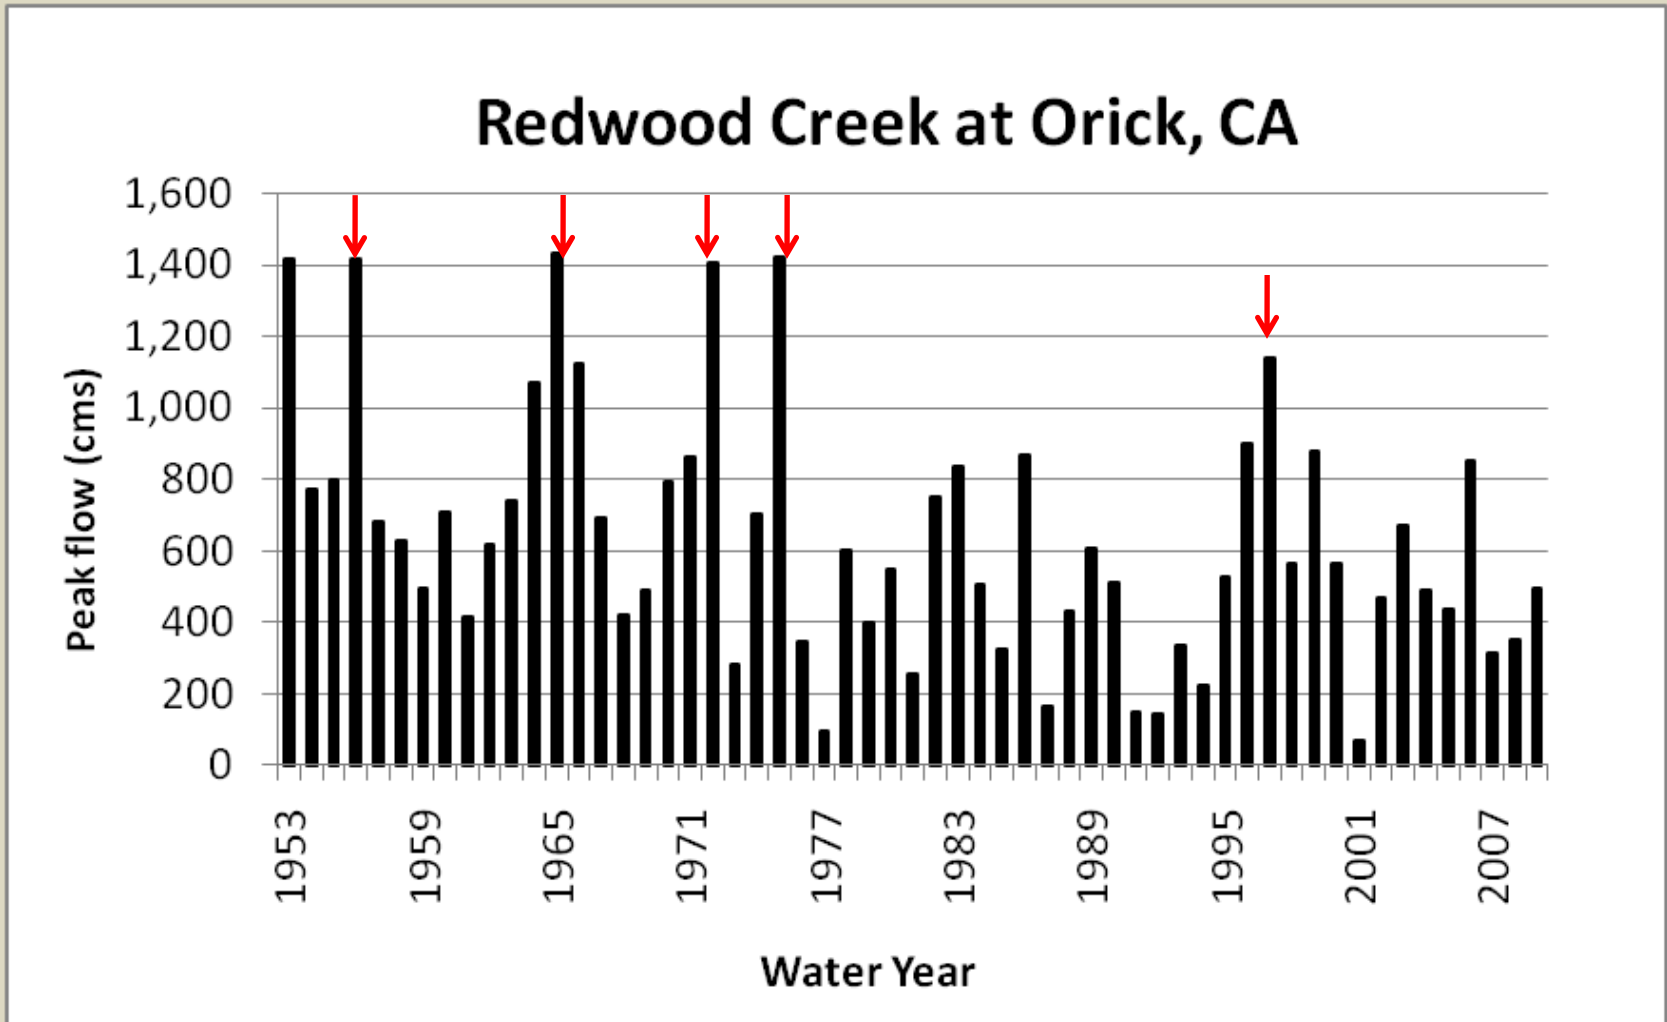
Peak Flows in Redwood Creek

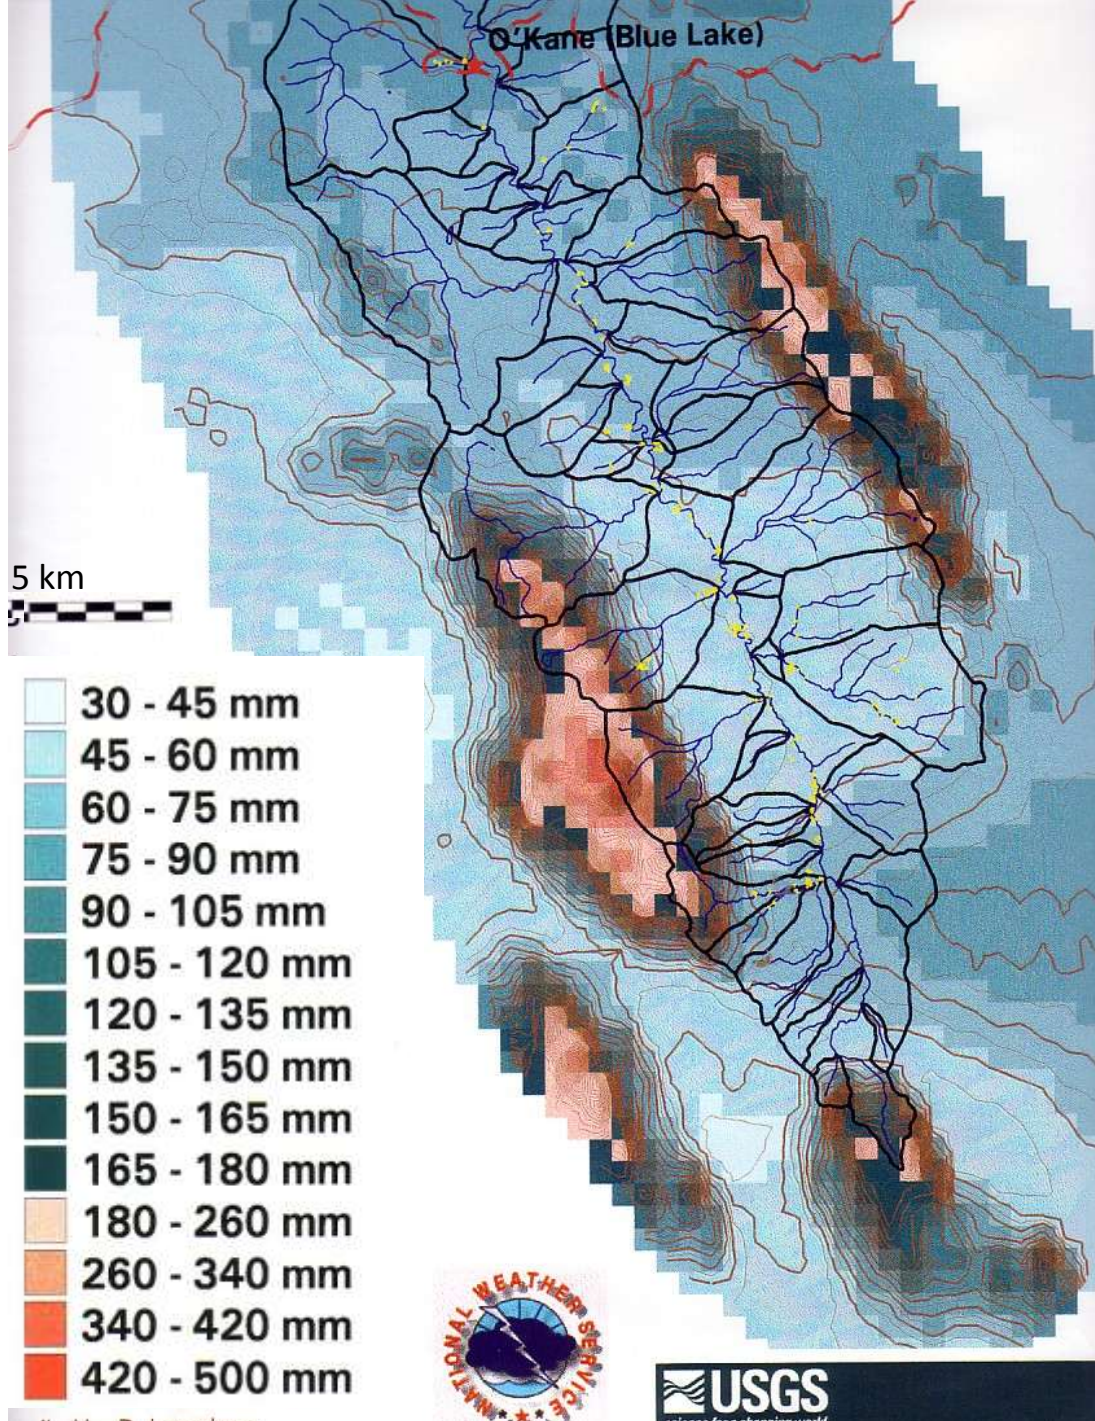
24-hour rainfall
from Doppler
radar data,
January 1, 1997
